PG&E Letter DCL-07-073

Docket No. 50-275, OL-DPR-80
DCPP Unit 1
Licensee Event Report 1-2007-002-00
Manual Reactor Trips During Mode 3 Rod Testing Due to Crud Related Rod
Slippage

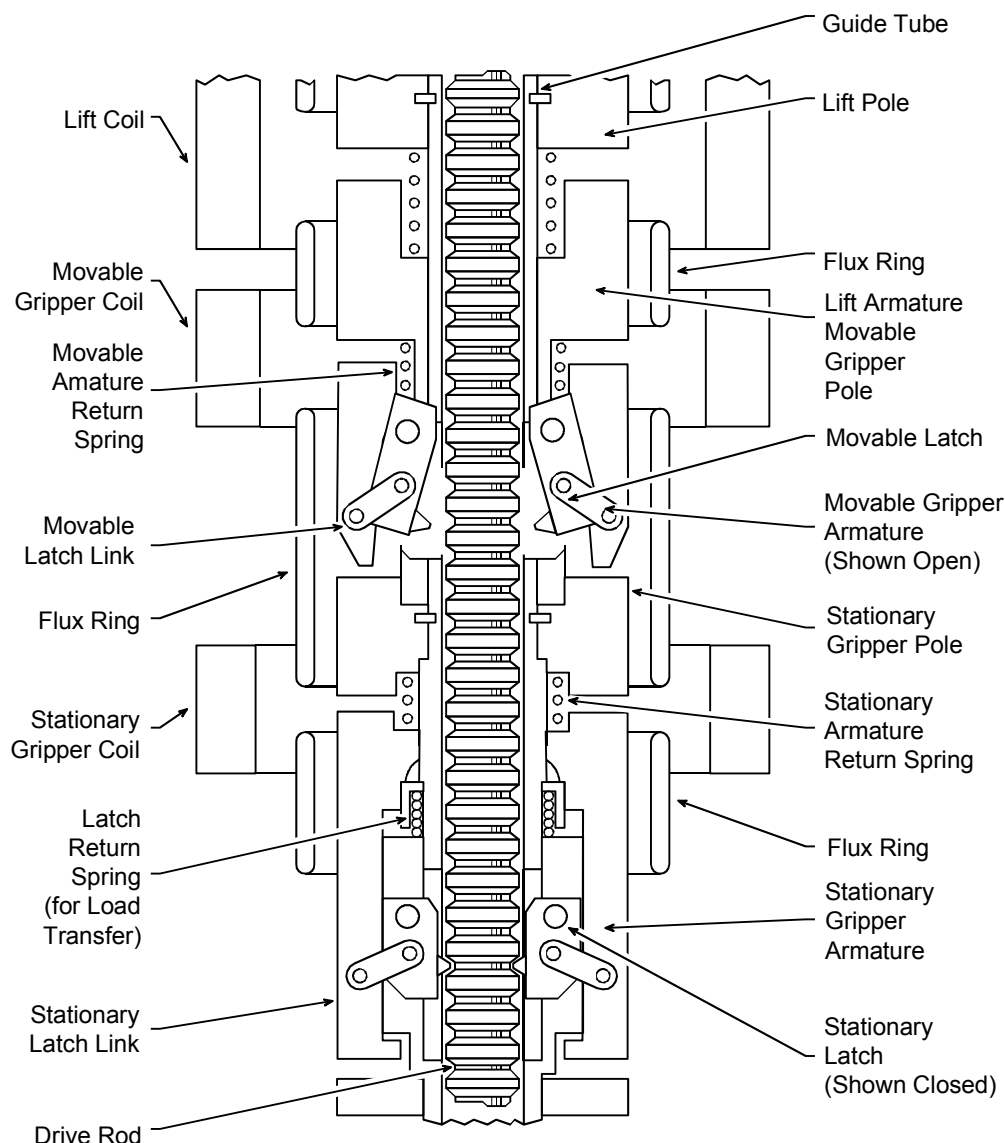
Rod Stepping Mechanism

Because the CRDM is inside the RCS pressure boundary in a low flow area above the reactor head, activated corrosion products (crud) can migrate and deposit in this area. Ferromagnetic and, to a lesser degree, paramagnetic materials would also be attracted to the CRDM components due to the strong magnetic fields created by the coils. Industry experience has demonstrated that these factors infrequently occur but can affect CRDM performance.
